# SERVICE BULLETIN

## SB-08-217

#### Potential for Water Contamination in Hub Due to Flooding

## Service Alert: Potential for Water Contamination in Hub Due to Flooding

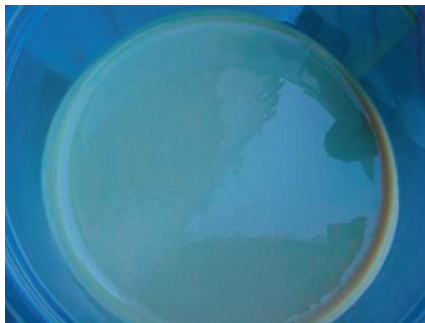
A visual inspection of the hub lubricant is advised. Oil, such as a 50 weight synthetic, with a small amount of water added will turn to a milky white color (figure 1). Semi-fluid grease will also turn a milky color. However the color change will depend on the grease's base color. Figure 2 shows semi-fluid grease after water contamination. Its base color was a red/pink color and after contamination the lubricant has turned a milky shade of pink.

Figure 1: 50 weight synthetic oil contaminated with a small amount of water turns milky white.

Contaminated lubricant should be removed from hub assembly and replaced with new lubricant. Hub cavity should be thoroughly cleaned to ensure removal of all contaminated lubricant.

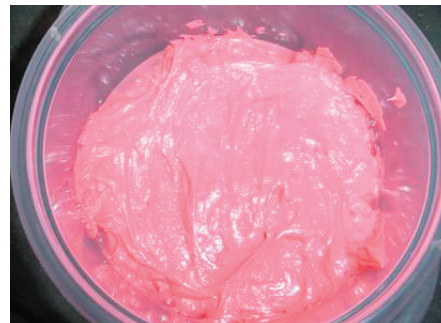
Figure 2: Red/pink semi-fluid grease contaminated with a small amount of water turns milky pink.
